CASE STUDY

WHERE? Cambridge Road, Meadowbank Roundabout

WHO WAS THE CLIENT? Hertfordshire County Council

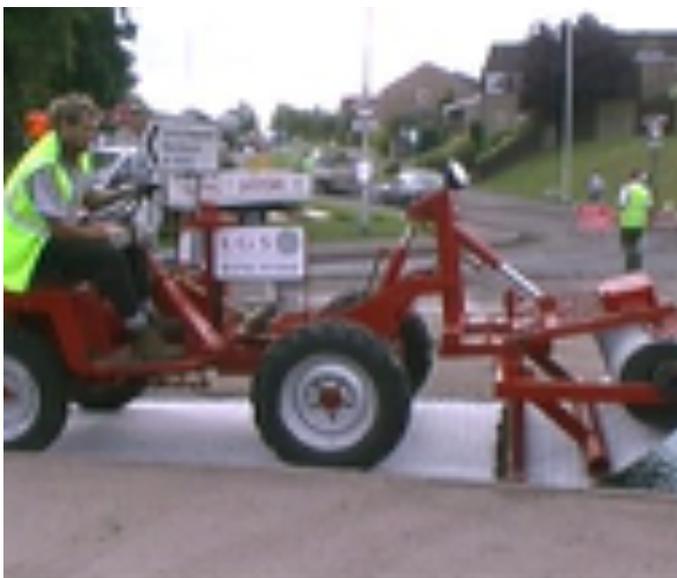
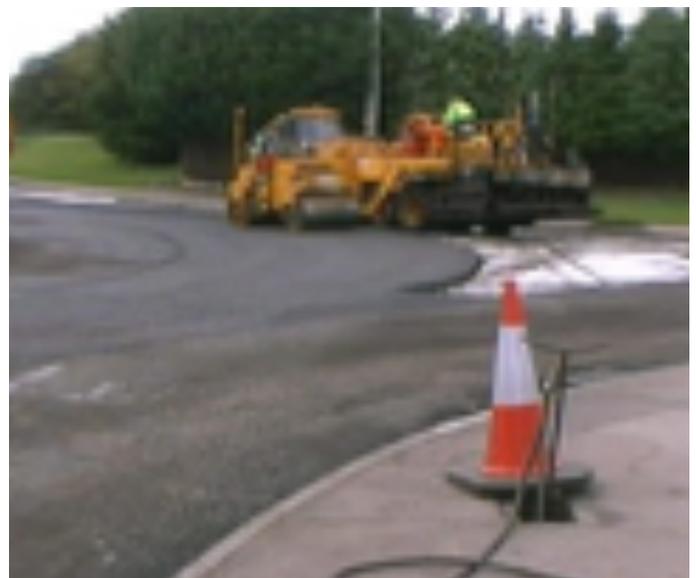
The existing road consisted of a concrete road base with asphaltic upper layers and was severely cracked.

Over a weekend in 1999 the top 90mm of surface was milled off, on both the roundabout and the adjoining stretches of the A505. On the roundabout and immediate approaches only Tensar Glasstex® P100 was laid on to hot 200 pen bitumen which had been sprayed at a rate of 1.0 litre/m² on to the planed road surface. This was laid by specialist installer Foster Contracting Ltd using their purpose made lay-down rig which places, tensions and brushes the Glasstex® on to the surface. A little over 2,000 m² of Glasstex® was installed over a weekend on two consecutive afternoons, to comply with the programme and traffic management constraints.

A conventional HRA base course followed by a 30mm thick asphalt surfacing layer was machine laid directly over the Glasstex® on the roundabout and on to a tack-coated milled surface on the adjoining A505. In 2005 this resurfaced but unreinforced adjoining A505 had deteriorated to a degree that the client decided to resurface it, while the roundabout was deemed not to warrant re-surfacing.
