Project: **Asphalt SAMI layer Installation**

Location: **A143 Bungay Norfolk, UK, July 2003**

## Case Study: 001

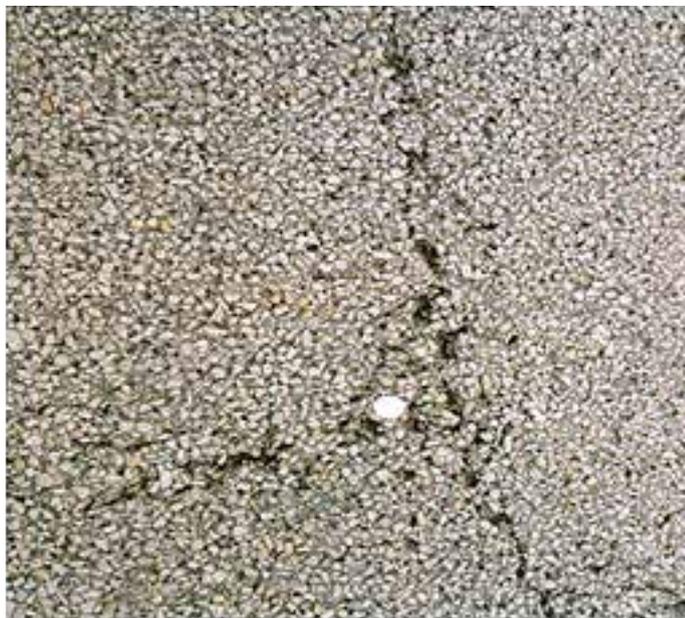
The A143 Bungay Bypass was constructed in the early 1980's. The original HRA surface was overlaid in 1995 with 25mm thickness of 10mm SMA. In 2003, although the road had retained its shape, several severe cracks were present and the road surface appeared 'tired' and 'brittle'.

Surface cracking before installation

Fifteen sections of the carriageway, totalling 10,800m<sup>2</sup>, where the cracking was most evident were selected for treatment with a SAMI. This consisted of a paving grade fabric laid onto bitumen over which a 6mm surface dressing was applied. Later the entire site including the sections of SAMI was surface dressed with 10mm chippings.

Normally, Norfolk County Council would have repaired existing cracks in the pavement prior to Surface Dressing. By laying the SAMI material, Norfolk engineers considered that such repairs could be omitted from the design, which resulted in a substantial cost saving to the construction. Mr Bob Noakes, Group Manager of the Norfolk Laboratory commented “the key to the success of Geosynthetics is good quality installation”.

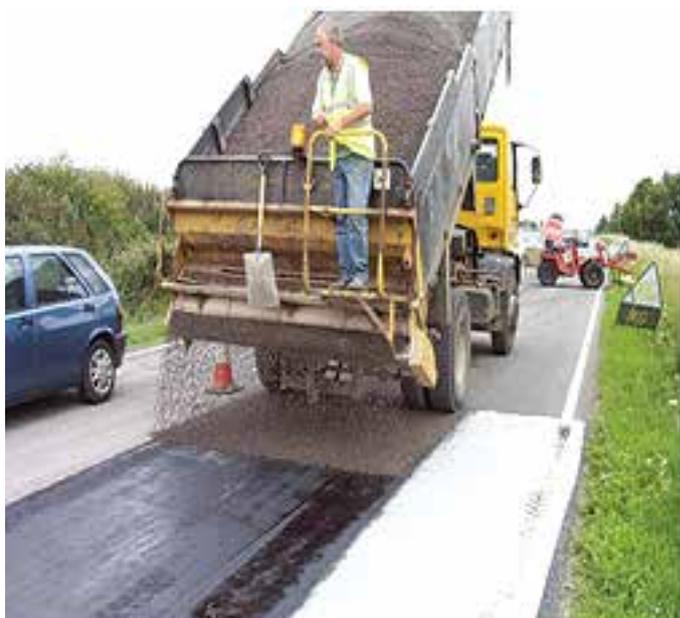
Over the 15 sections selected for SAMI treatment the surface was swept by mechanical sweeper, and a bond coat of hot 160/220 pen bitumen was sprayed by calibrated distributor at 0.6 l/m<sup>2</sup>, over which a non woven paving grade geotextile was laid. Adjacent panels were butt-jointed, as overlaps could potentially have formed a ridge in the final surface. A surface dressing was then applied on the fabric consisting of 6mm dry granite chippings laid onto polymer modified emulsion sprayed at 1.6 l/m<sup>2</sup>. The process was completed under Stop and Go traffic management.

6mm Granite Surface Dressing over paving fabric
