### Case Study: 003

Geosynthetic Installer:  
**Foster Contracting Ltd.**

Client:  
**London Borough of Tower Hamlets**

Situated within London Borough of Tower Hamlets, Middlesex Street is a very busy shopping street within the east end of London. Since the construction of the existing road, the surface, as can be seen from the photograph below left, had deteriorated significantly. This was due in part to fragmentation by utility works but also to the rigours of modern day traffic loadings. The road itself is approximately 1,100 meters long, more when the associated side streets, whose condition had also deteriorated and needed to be taken into consideration.

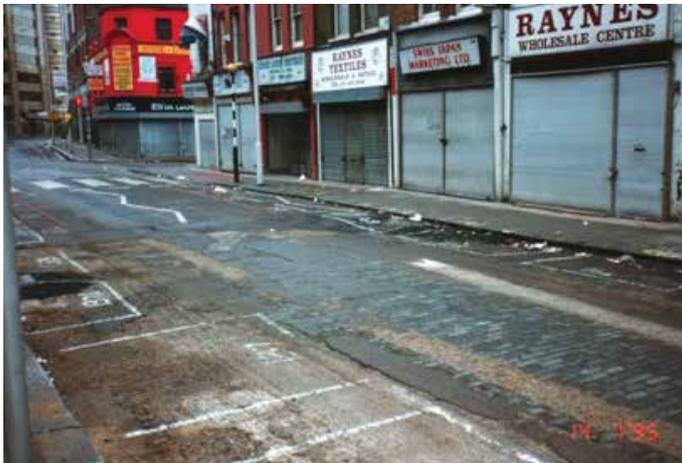
View of the existing road surface: 1995

After planing off the old surfacing, the exposed concrete carriageway was covered with 100kN/m x 100 kN/m composite geosynthetic, and overlaid with bitumen binder and surfacing layers.

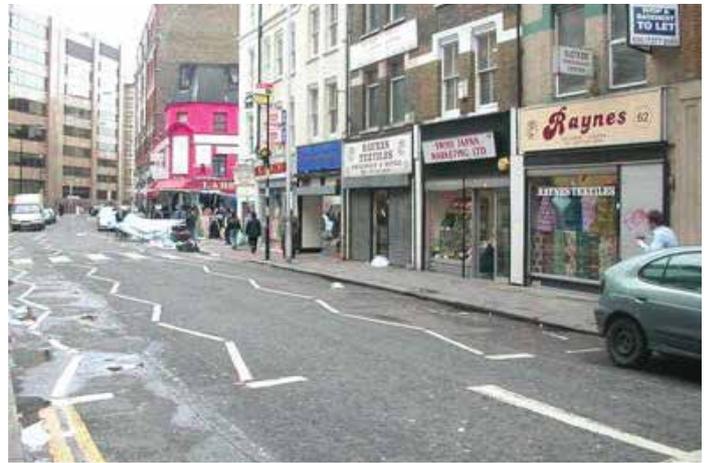
View of the road surface: 2007

Specialist contractor Foster Contracting Ltd. sprayed a 160/220 pen bitumen tack coat from their calibrated tanker at a rate of 1.1 litre/m<sup>2</sup>. FCL then used their specifically designed laying machine to lay the 100kN/m composite onto the hot bond coat and achieve the required sealing. Once these operations were complete, the composite was overlaid with 50mm of Hot Rolled Asphalt. In total, including the adjoining side streets 6.000m<sup>2</sup> of road was refurbished and as can be seen from the photos, the road surface is still performing well some 12 years on.

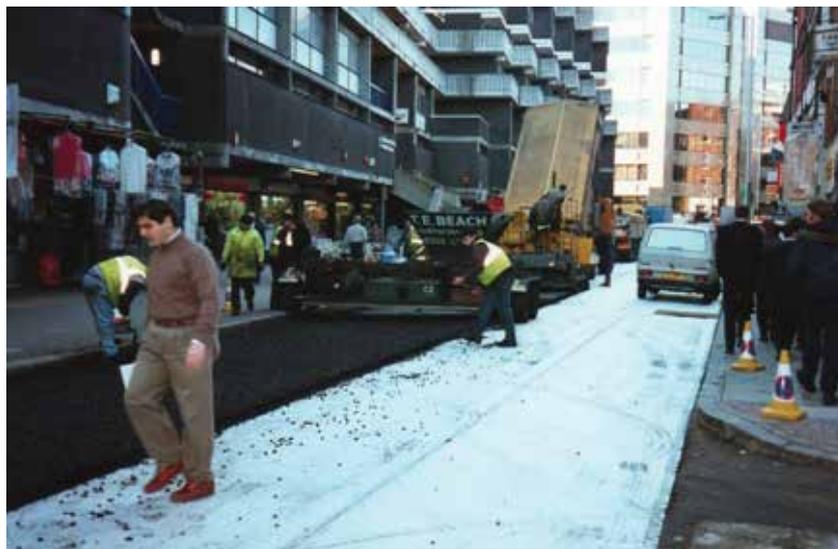
*Hot rolled asphalt surfacing*
