CASE STUDY

WHERE? Cambridge Road, Meadowbank Roundabout

WHO WAS THE CLIENT? Hertfordshire County Council

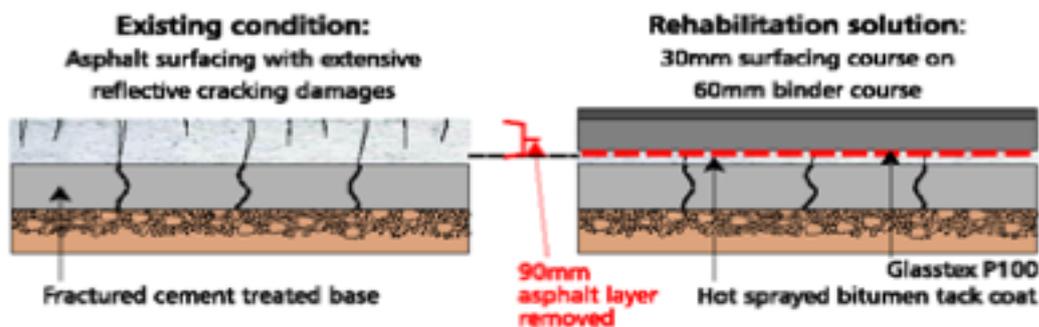
CHALLENGES:

The roundabout and adjoining road, the A505 were subjected to severe loading, mainly from a combination of heavily loaded lorries travelling from a nearby quarry and also from regular local buses. The road was badly cracked and in need of re-surfacing and strengthening.

The upper 90mm of asphalt was milled off and in addition at the roundabout 200 pen straight run bitumen was spray applied and Tensar Glasstex® P100 paving composite was then immediately installed by machine directly on to the planed surface. A conventional 60mm thick HRA base course was placed on top followed by a 30mm thick surfacing.
