CASE STUDY

WHERE? Ipswich Docks

WHEN? 2005

WHO WAS THE CLIENT? Associated British Ports

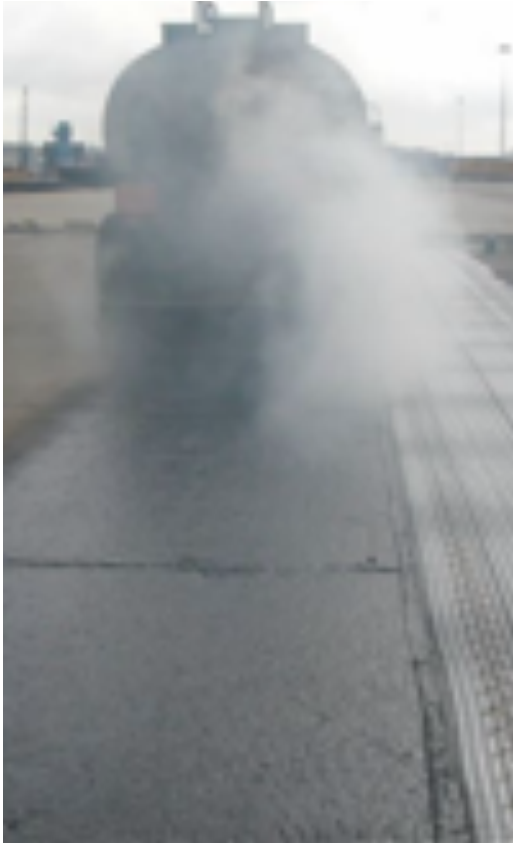
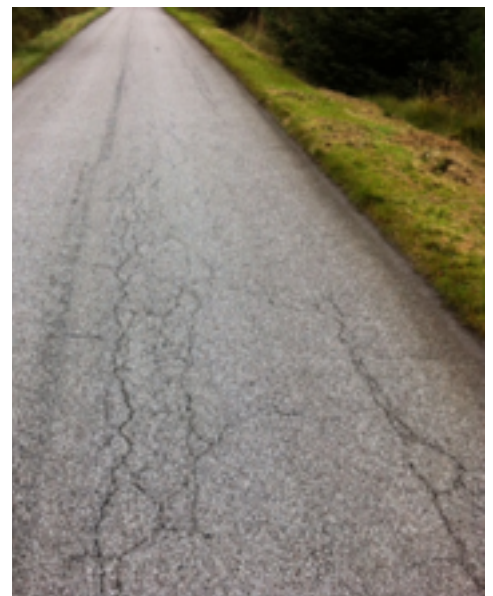
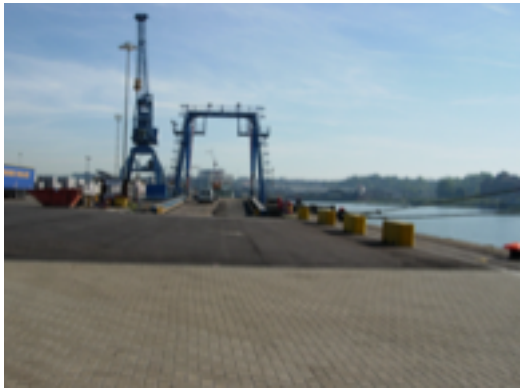
Cracks in the existing concrete RoRo ramp slab were sealed. Specialist asphalt geosynthetic installer, Foster Contracting sprayed the specified 1.1 litres/m² of 160/220-pen bitumen bonding coat onto the concrete surface.

Fosters then machine installed the Glasstex P100, using their specially developed Geosynthetic Applicator. The Glasstex is laid with its glass reinforcing fibers upwards and the Applicator's brushes ensure good adhesion to the hot bitumen bonding coat. Rolls were lapped by 150mm

As soon as the Glasstex had been laid it was ready for placement of the 55/10 hot rolled asphalt (HRA) surfacing. This was laid in a single 45mm thick layer using a conventional paver.

Glasstex P100 was installed directly onto the concrete slabs to control cracking and a 45mm thick hot rolled asphalt overlay was machine laid on top.
